CASE STUDIES: NON-STANDARD APPLICATIONS OF EQUALIZER TOOLS

#2.0: FLANGE ALIGNMENT EXTENDED REACH TOOL

FLANGE ALIGNMENT CASE STUDY

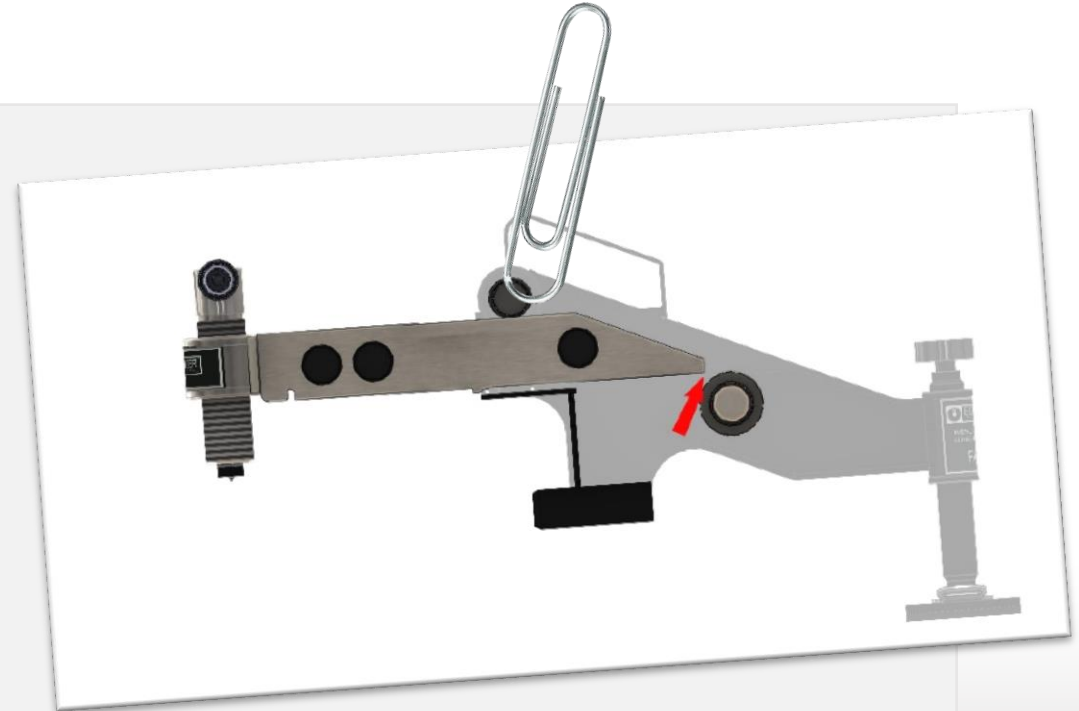
TOOL RECOMMENDATIONS:
based on flange size, standard
Equalizer tools are too small

Equalizer **FA9TE** had
insufficient wing-reach for this
flange-joint.

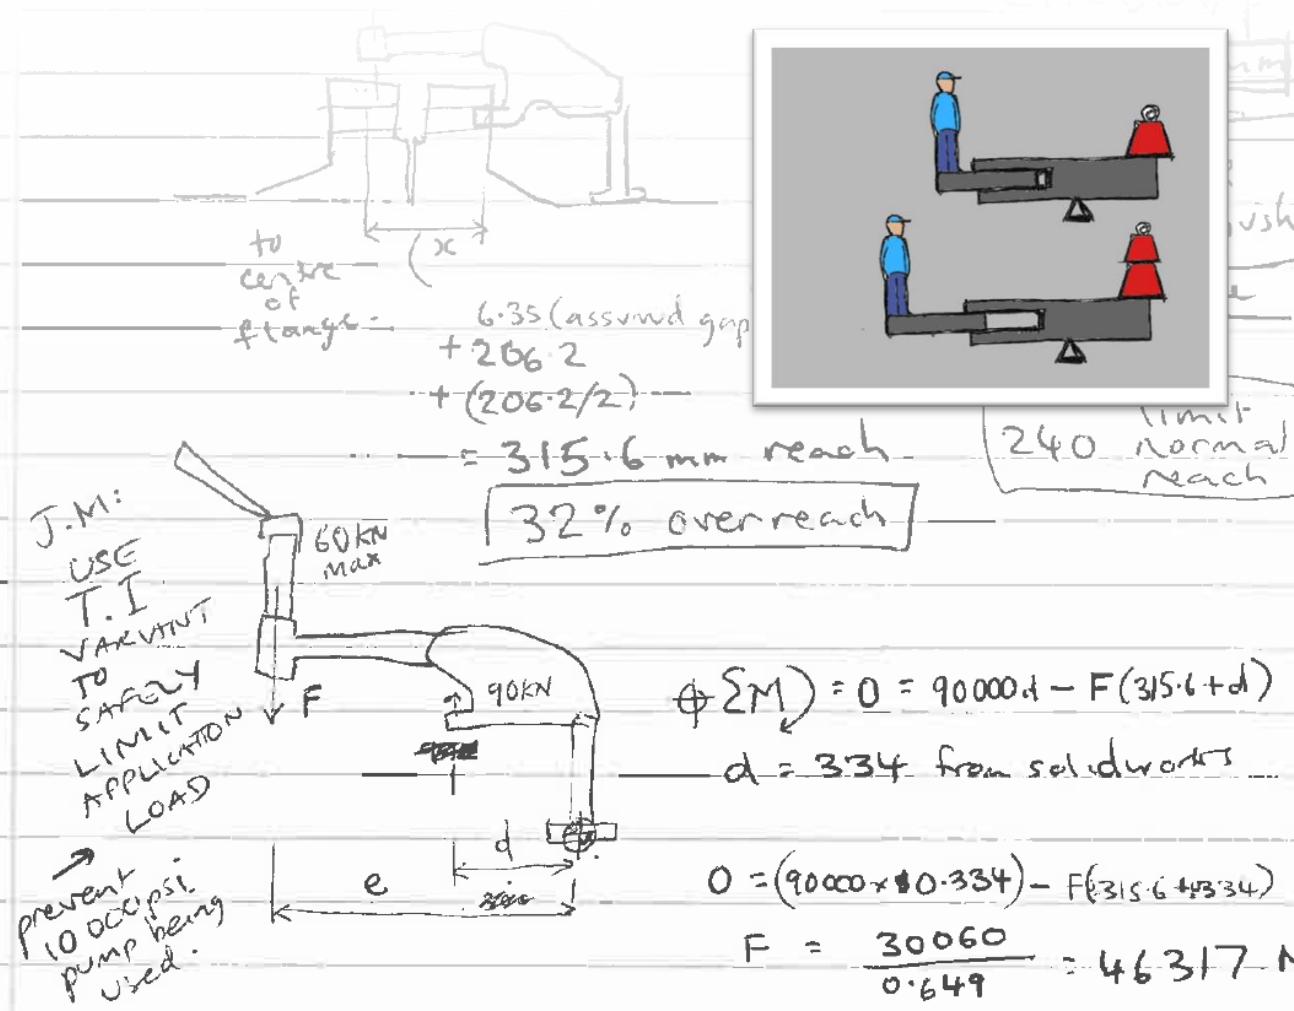
Tool modification required – calculations, development and testing required.

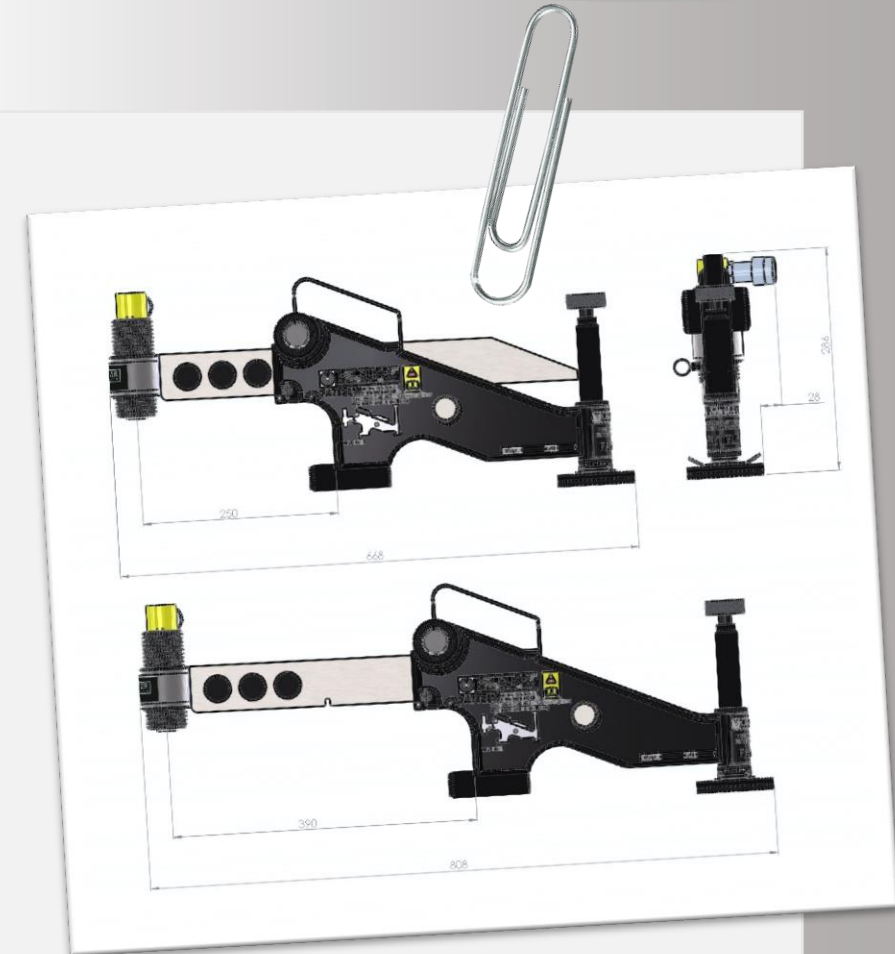
- New Extended Reach Hydraulic Alignment tool proposed
- Down-rated hydraulics specified to prevent over-load - caused by increased torsional stresses due to longer wing

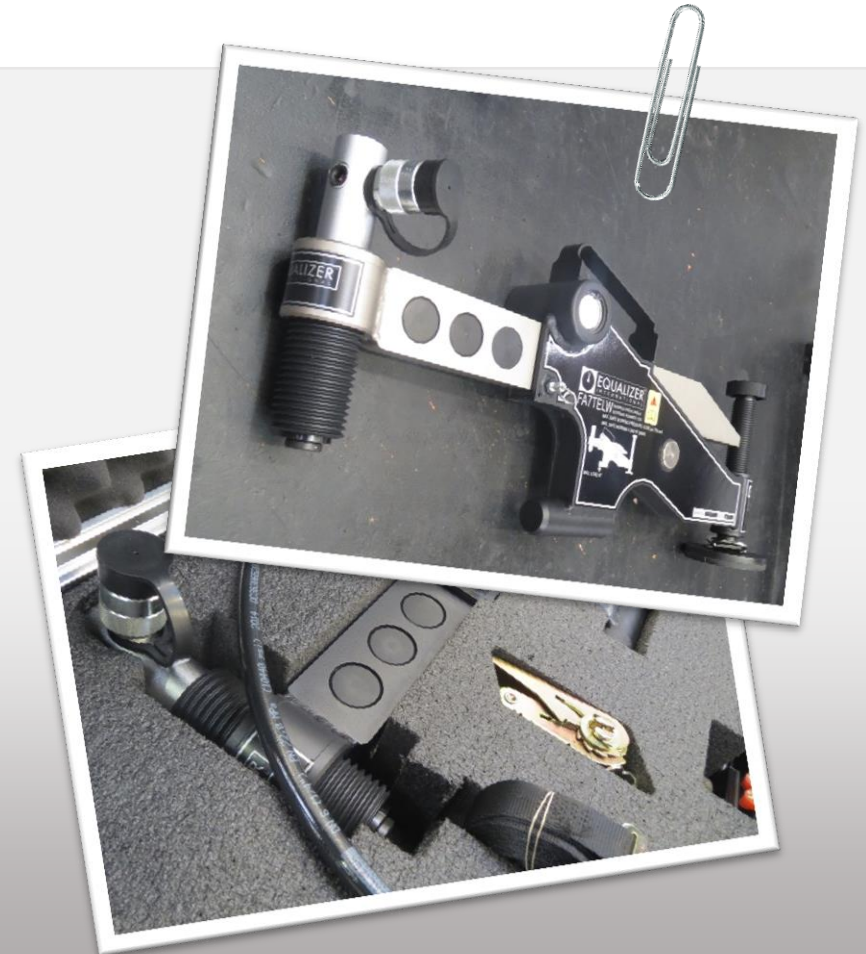
- FA7TELW
Long-Wing Hydraulic Flange Alignment Tool.
- Tool supplied within 10 days
- 90% of standard FA9TE components shared

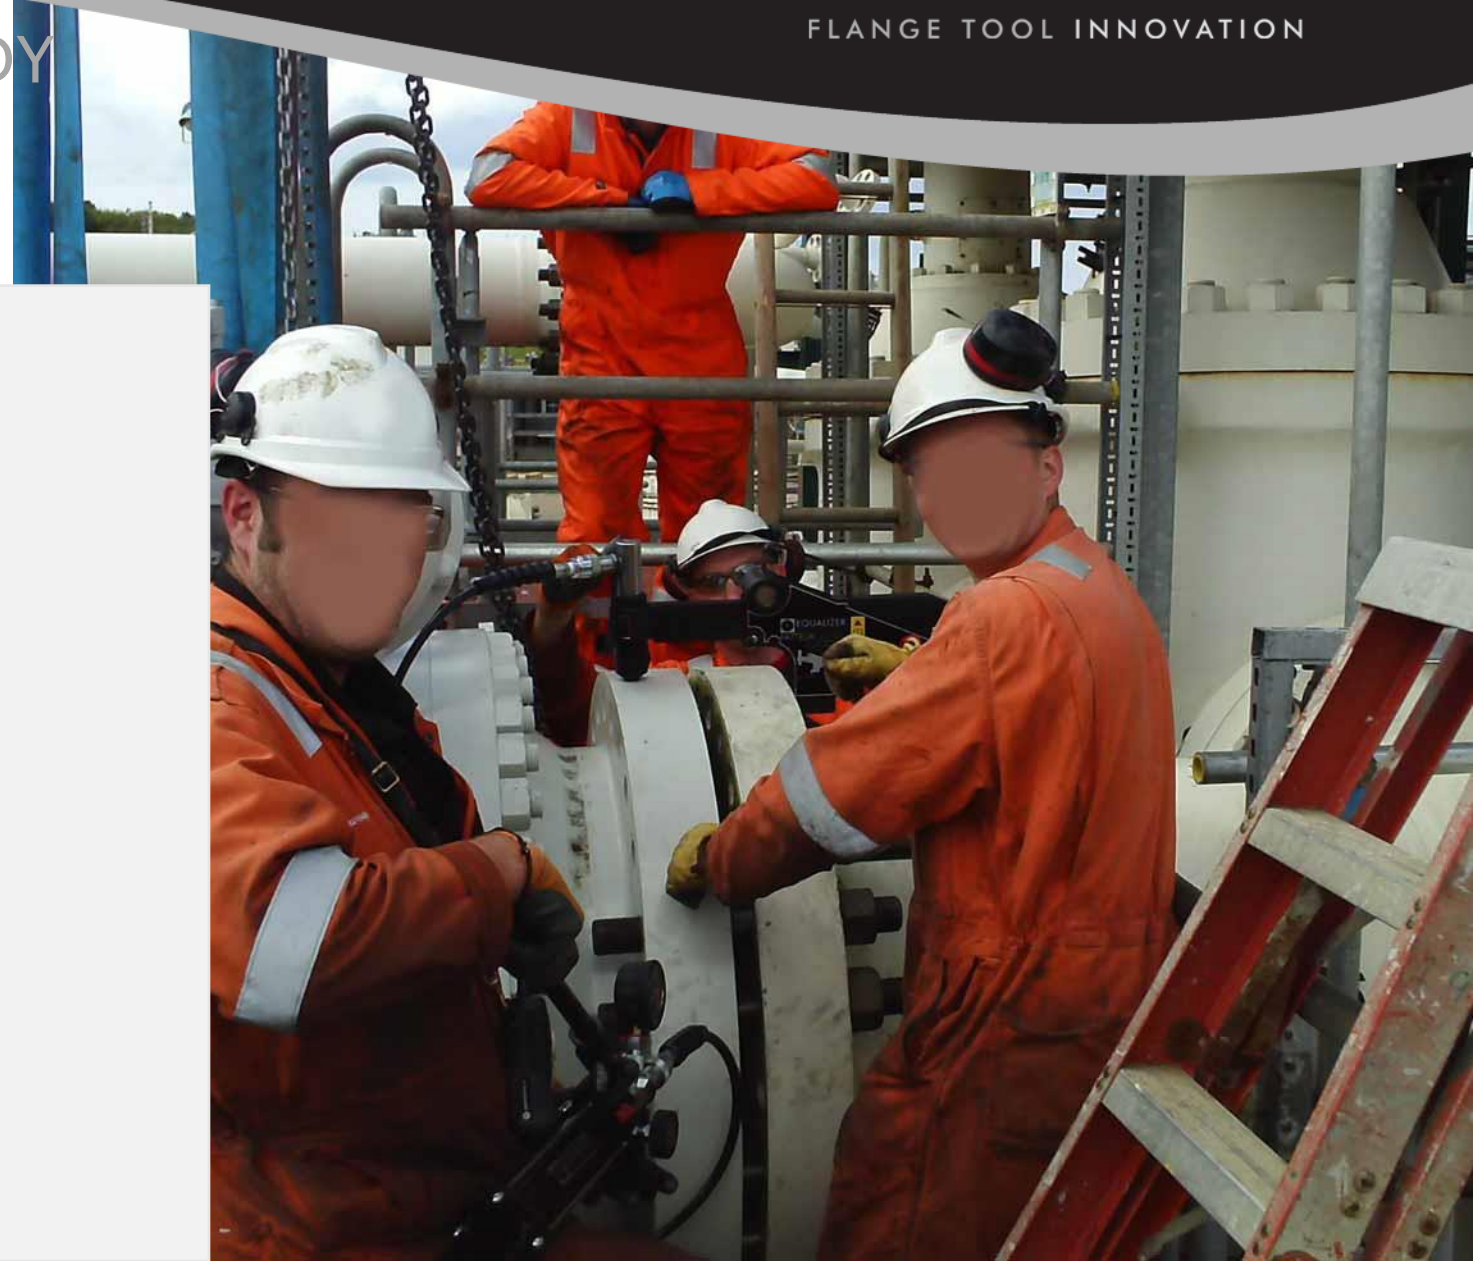
2.7 OUTCOME

- Tools delivered within promised time-scales
- Customer delighted with performance of tool.
