FLANGE TOOL INNOVATION

CASE STUDY

CS-2013-03

REMOVAL OF DAMAGED QUILL FROM
PIPELINE

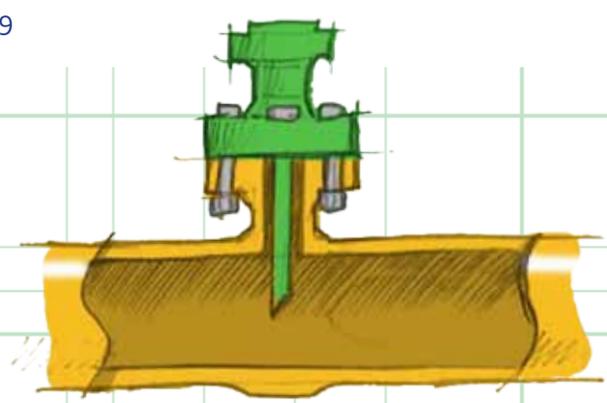
be so bent out of shape that it was lying flat against the bore of the pipe, perpendicular to its intended position.

The quill had been designed to be removed from a small access aperture in the side of the pipe-line by unfastening its flanged connection and sliding it straight outward. As the quill was bent around, once the bolts had been removed from its flange, the device could not be removed. Gaining access to straighten or break the quill were impractical, so some means of extracting the device through its intended aperture was required.

Equalizer International were approached to suggest appropriate tooling for the removal of a damaged quill. A pipe-line chemical injection quill had been damaged by a heavy object passing within the pipe-line, such as an intervention tool or pig. The blunt force had caused the narrow pointed quill to

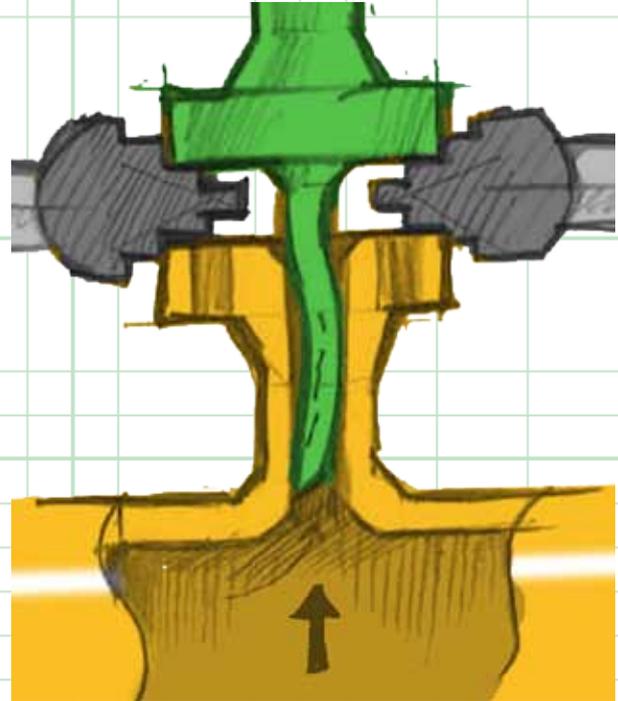
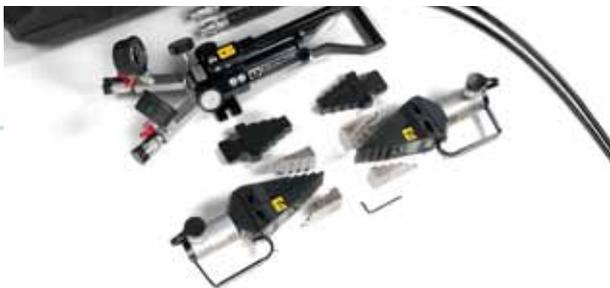
Equalizer proposed the use of its high-power spreading wedges to extract the quill. Several SW15TE tools were employed in the 6mm access gap between the flanges, and the large spreading capabilities of the tool enabled the quill to be pulled out, straightening the bent shaft gradually as it was pulled outwards.

Down-time was minimised, no personnel were endangered, the flange and pipe-work were undamaged. The quill remained unbroken, so no fragments were lost into the pipe-line.
