FLANGE TOOL INNOVATION

CASE STUDY

CS-2016-02

REMOVAL OF CORRODED NUTS

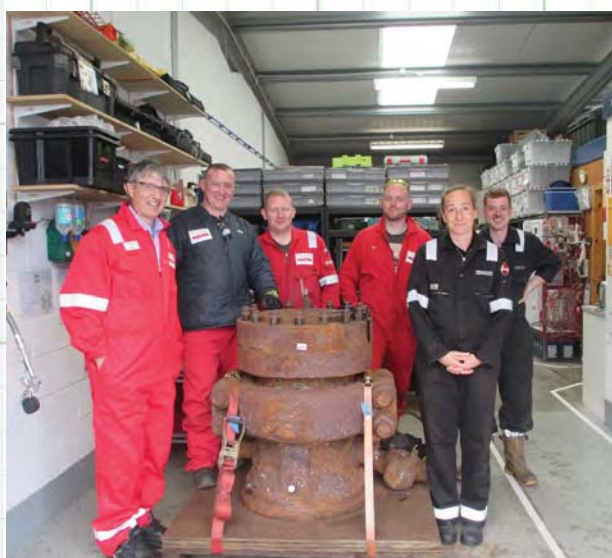
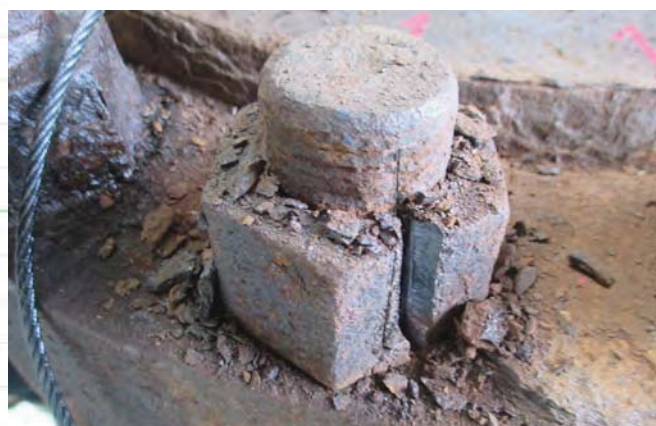
API 6A 13 5/8" 5M flange with 16 x 66mm AF seized nuts.

The flanged connection was "made up" in 1979 (37 years ago) and was so corroded that a torque tool was unable to loosen the nuts.

Together with the Equalizer team, ThinJack used the Equalizer NS36TE Nut Splitter to cut the nuts. After cleaning away the loose rust the average time to split each nut was 12 minutes with hydraulic pressures of 6000 to 8000 psi. (NS36 max working 10,000 psi)

Each of the 16 nuts were cut twice during the process to enable rapid removal of the nuts in two halves.

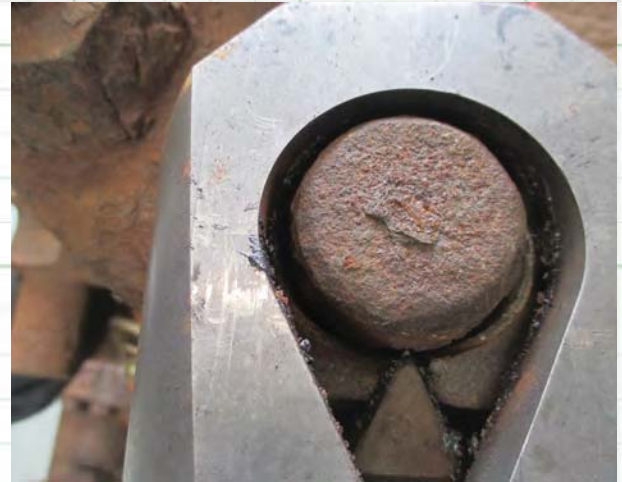
A single cutting tip was used throughout the operation. After removal of all the nuts the cutting tip showed no sign of wear and would have gone on to cut many more nuts before requiring replacement.

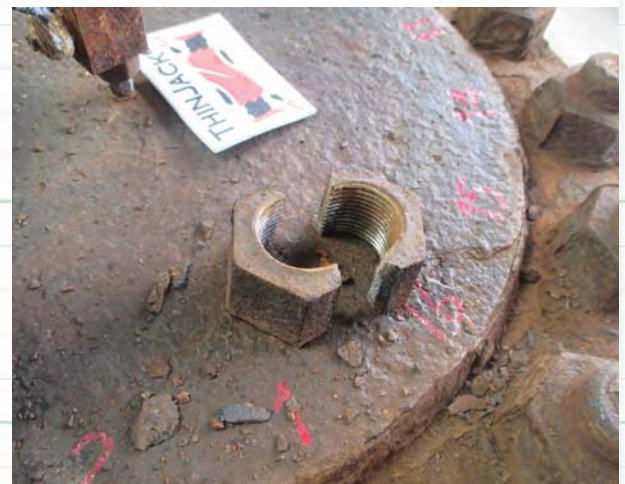
ThinJack was extremely pleased with the end result which meant that the flange could then be separated. They will now use the NS range wherever they can going forward.
